Developing a Proof of Concept for an Autonomous Runner Cutter in Strawberry Production in Plasticulture

Summary

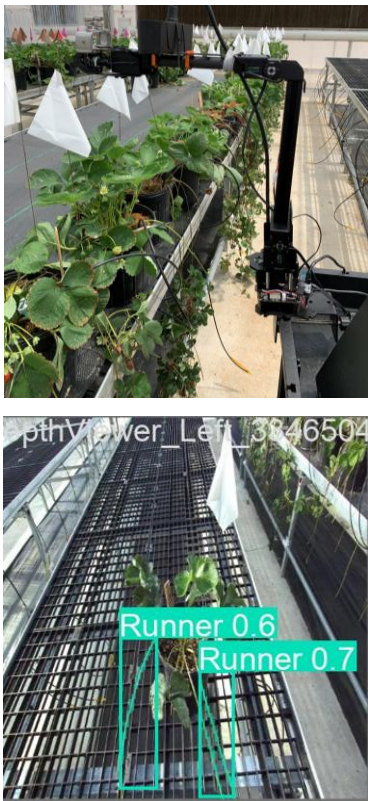
Figure 1. The setup of the AI-guided runner-cutting system in a controlled greenhouse environment. The upper image shows the robotic arm positioned beside strawberry rows, and the lower image displays the RGB camera's detection view with bounding boxes identifying runners and their confidence scores.

The AI-guided robotic system performed reliably under controlled conditions and successfully demonstrated the feasibility of automated runner cutting using depth imaging (Figure 1). Across all trials, the system achieved approximately 50% successful cuts, with each cutting cycle requiring about seven seconds from image capture to blade

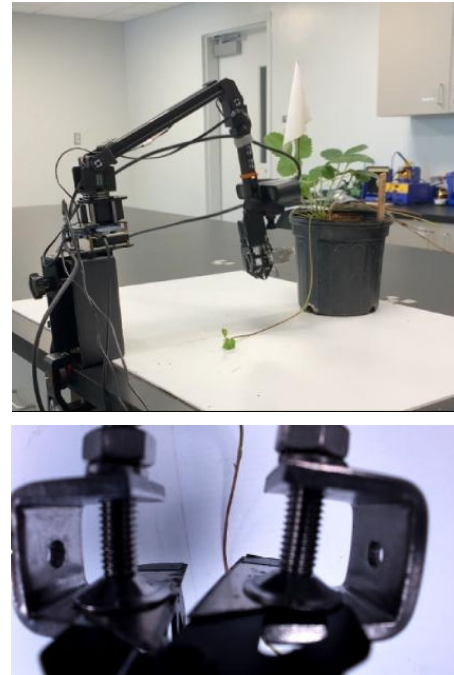
Figure 2. Laboratory demonstration of the robotic runner-cutting mechanism. The upper image shows the robotic arm aligning toward a detected runner on a potted strawberry plant, while the lower image presents a close-up of the dual-blade assembly during the cutting operation.

movement (Figure 2). The image processing and inference steps averaged three seconds per frame, while the robotic actuation and cutting phase took approximately four seconds. The study demonstrated that depth imaging provides a practical balance between accuracy, speed, and computational efficiency for automated strawberry runner cutting.
